Subject: Stairway to Roaring Brook at Matson Hill Open Space  
Inland Wetlands & Watercourses Agency  
Application for Permit

1. **Applicant's name:** Town of Glastonbury
2. **Title of project:** Staircase to Roaring Brook at Slocomb Pond Dam Removal
3. **Address or descriptive location of proposed project or regulated activity:**  
Construction of a staircase from the Matson Hill Open Space to Roaring Brook as a part of the larger project - the removal of the Slocomb Pond Dam

**PHOTO LOG**  
**WETLAND DELINEATION**  
**Slocomb Dam**  
**Matson Hill Road – Glastonbury, CT**

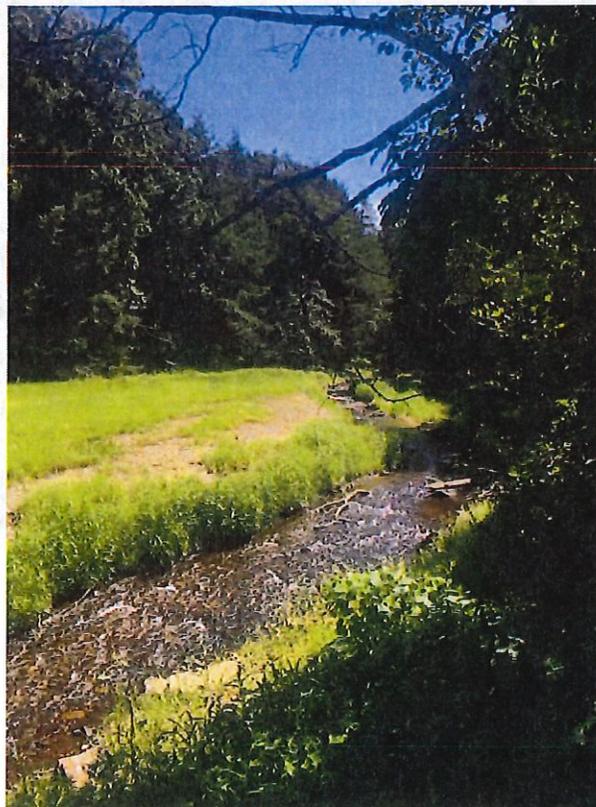
Area south of dam showing impounded sediments.

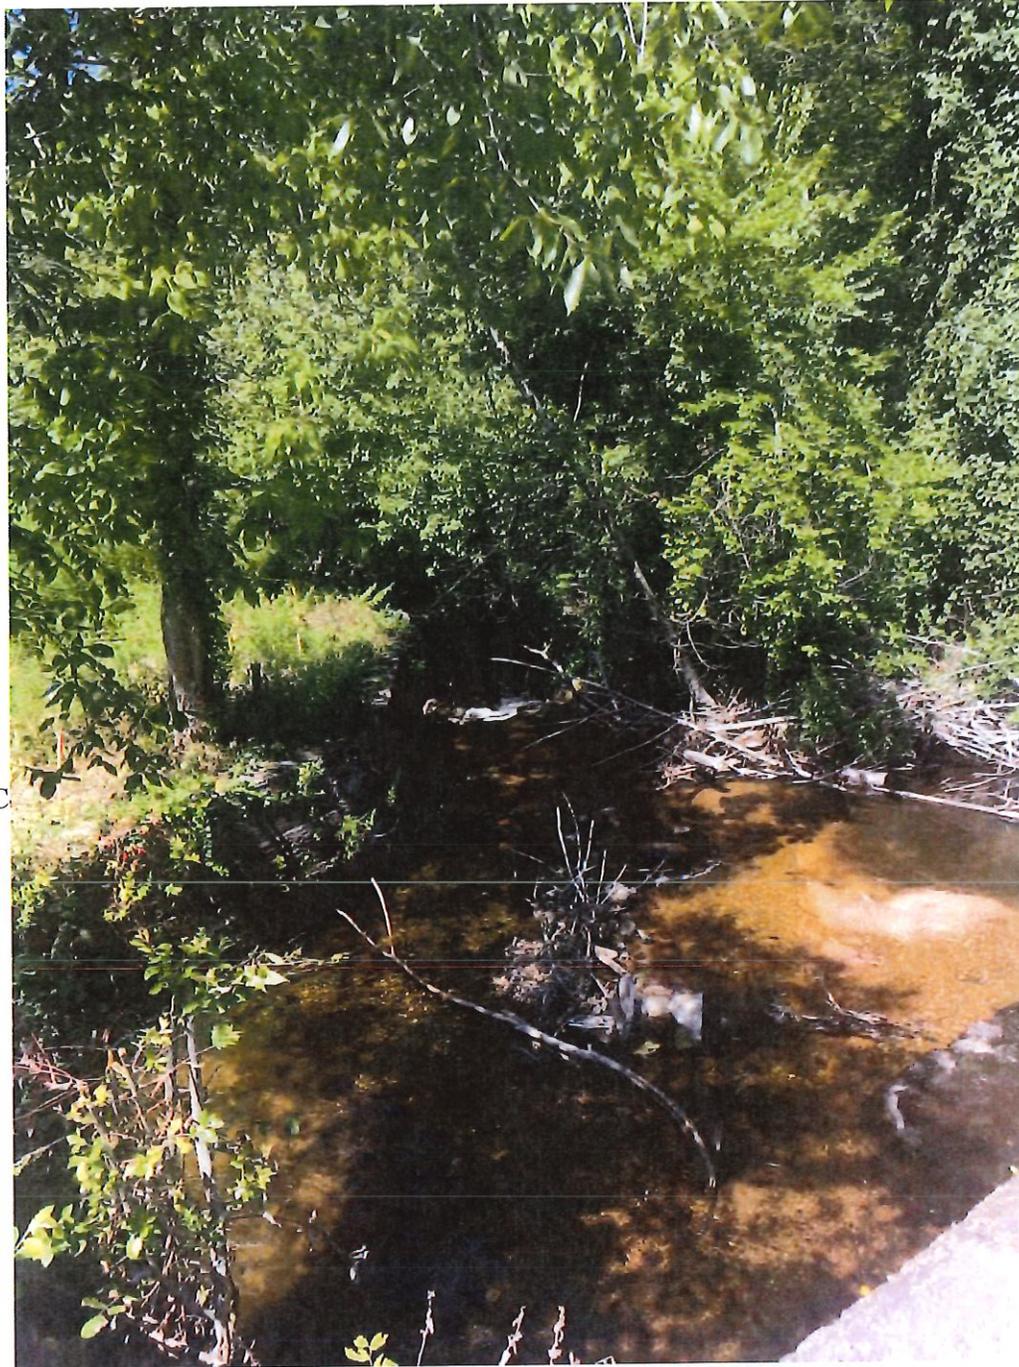
Area immediately down stream of dam showing stone retaining wall.

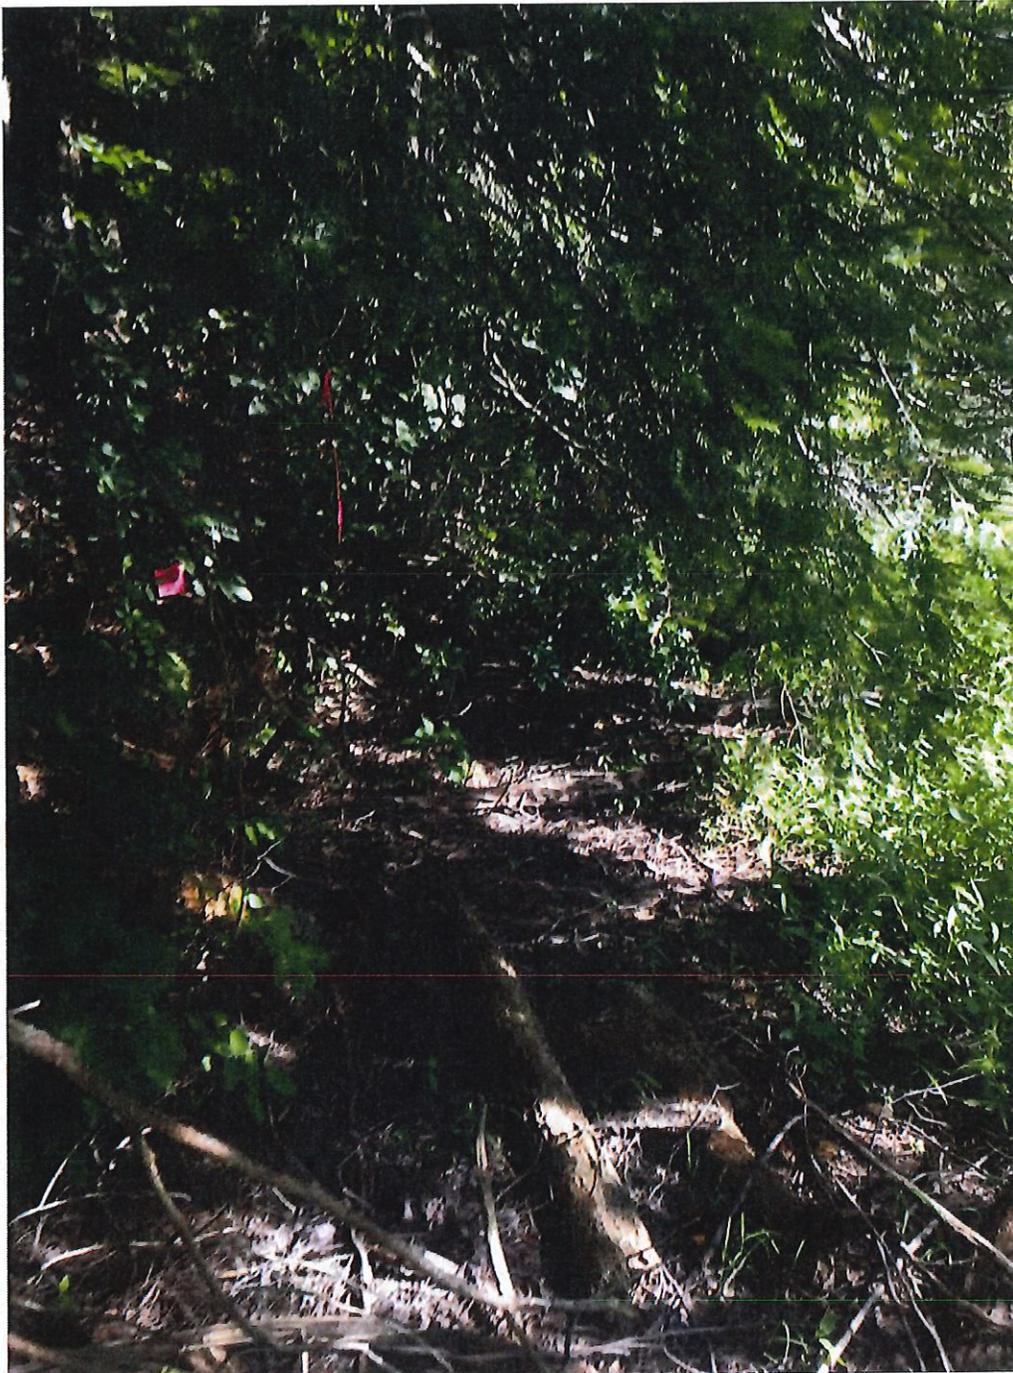
Photo 11: High water line along north bank.

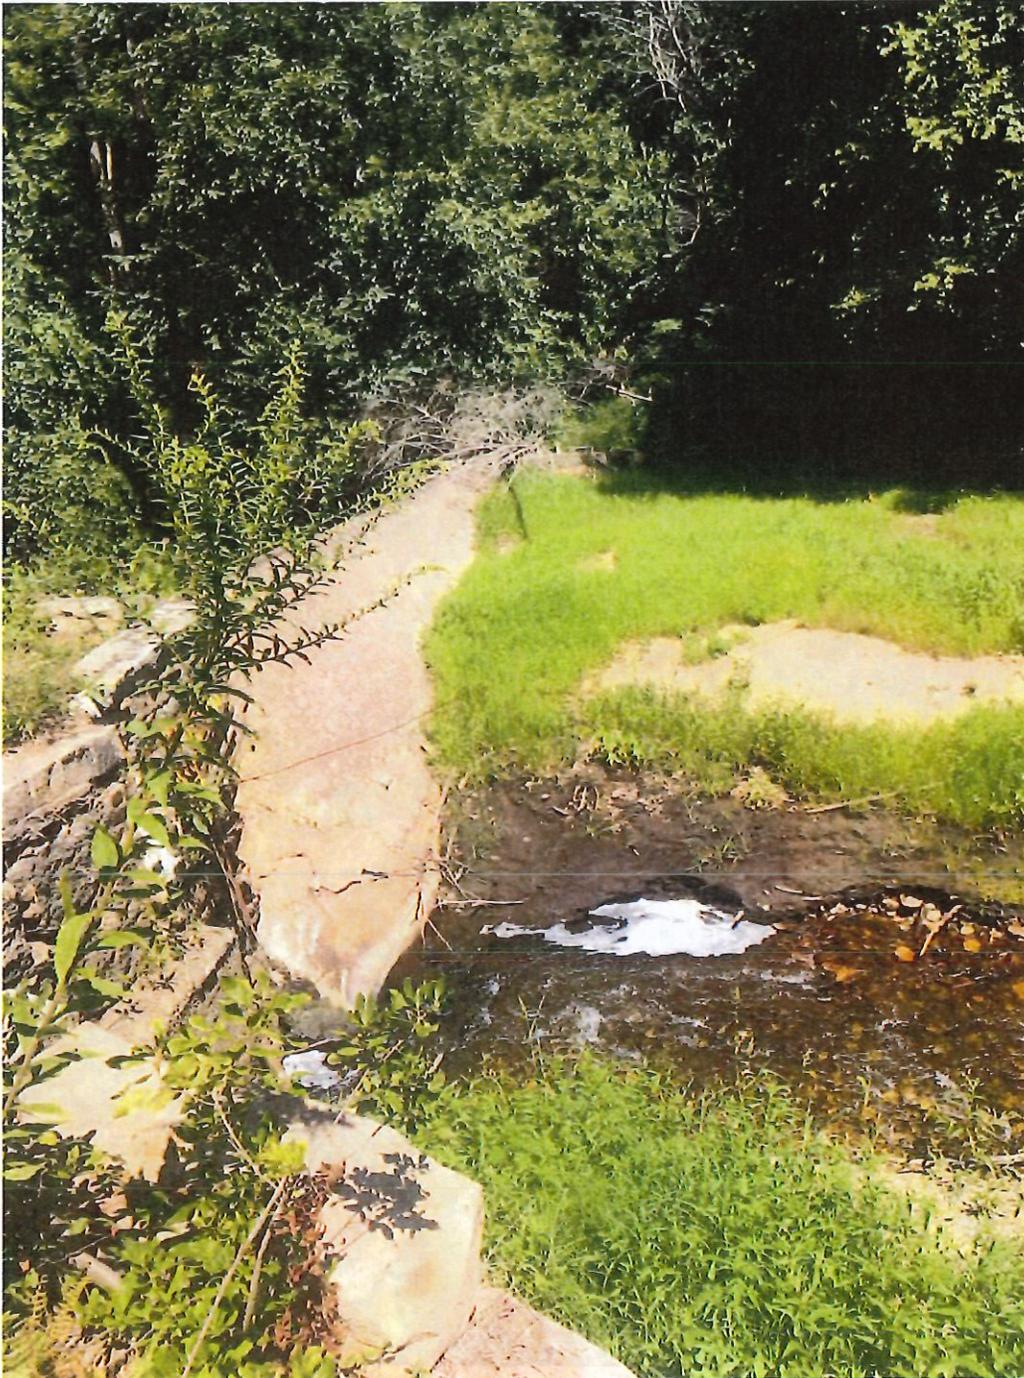
Watercourse entering low flow outlet at dam.
